Revised Feasibility Study for Woodstock Public Library

Part A: Needs Analysis

Part B: Concept Development

April 11, 2007

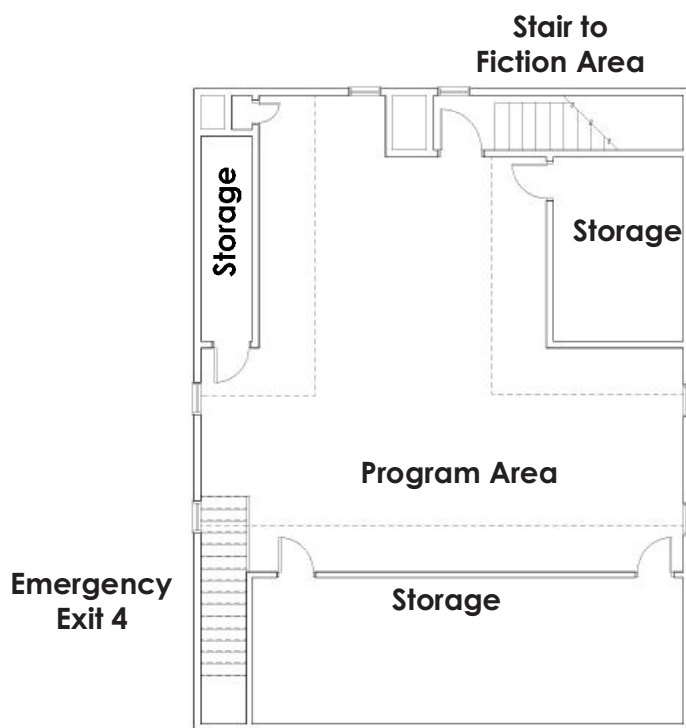
SECOND FLOOR PLAN

SECOND FLOOR (1,412 net square feet; 1,704 gross square feet)

This area is readily available for public use via an open stair in the fiction collection, but the floor is not accessible by handicapped individuals.

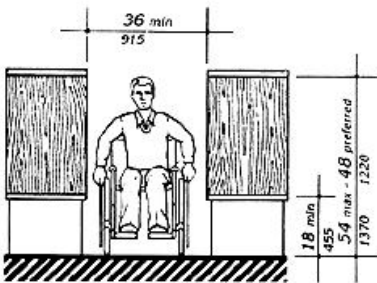
Minimum clear aisle space at card catalogs and magazine displays shall comply with **Figure 55**. Maximum reach height shall comply with **4.2**, with a height of 48" preferred irrespective of approach allowed.

1. Some aisle widths at book stacks do not meet code requirements. Figure 55 requires the minimum clear width at book stacks/aisles to be 36". In many areas throughout the building, this minimum standard is not met, in violation of 8.5, 4.2 and 4.3.
 - a. At the periodical area, end aisle width measured 35"; between the magazine rack and ends of stacks was measured at 24".
 - i. **Recommendation:** Reconfigure book stacks to provide acceptable aisle width minimum of 36".
 - b. At the reference area (near young adult), aisle width measured 34".
 - i. **Recommendation:** Reconfigure book stacks to provide acceptable aisle width minimum of 36".
 - c. At the book barn, many aisles were less than 36".
 - i. **Recommendation:** Reconfigure tables to provide acceptable aisle width minimum of 36".

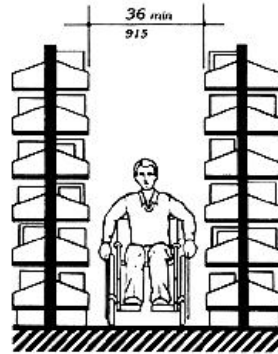
Figure 56

Minimum clear aisle with between stacks shall comply with **4.3**, with a minimum clear aisle width of 42" preferred where possible. Shelf stack height is unrestricted (See **Figure 56**).
